Ethics and materials

Some Spanish Case Studies

Santiago Huerta Fernández

Stratégies d'intervention
pour la cathédrale de Lausanne

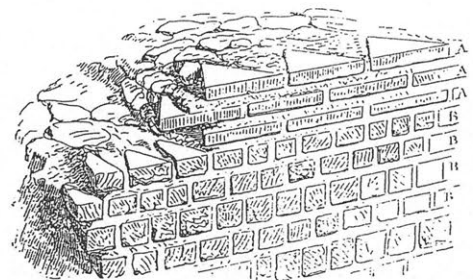
2 a) Section through a medieval building; b) and c) detail of a roman and medieval wall (Viollet-le-Duc 1858).

The material of historic architecture is not simply stone or brick, but stones or bricks plus a certain mortar and bonded in a certain way. We can produce a great variety of masonry using the same stone, from irregular rubble to ashlar masonry, passing through Roman concrete. Besides, masonry elements are composite structures. Maybe the best example is the medieval wall (fig. 2b). The wall consisted of an external parament, made of ashlar masonry, and circa one foot thick (25–30 cm); the stone is usually of a certain quality as it must withstand the atmospheric agents (wind, rain, freezing). On the interior, we find another parament, maybe of the same thickness or less, usually built with low quality stone as it is protected. Between both paraments there is a filling made of irregular rubble masonry.
